## Underlying issues on the selection, use and conservation of building limestone

**Abstract:** An argument is presented that, despite popular assumptions, many limestones, especially the wide range of clastic and, in general, granular limestones, do not decay in a steady and predictable pattern in response to slow dissolution. Instead these stones, especially when used in construction in polluted environments, invariably decay episodically through physical breakdown. Most commonly this is accomplished through a variety of salt weathering mechanisms that, if unconstrained, can lead to the rapid, catastrophic decay of building blocks and their complete loss – a process that has driven the extensive programmes of stone replacement that are typical of buildings constructed of these stones. In polluted environments, especially those rich in sulphur and particulates, the most common constraint on accelerated decay has been the rapid development of gypsum crusts that, for example, could rapidly 'heal' the scars left by contour scaling. It is ironic, therefore, that any reduction in pollution could conceivably lead to increased erosion by retarding this healing process. Because of this t

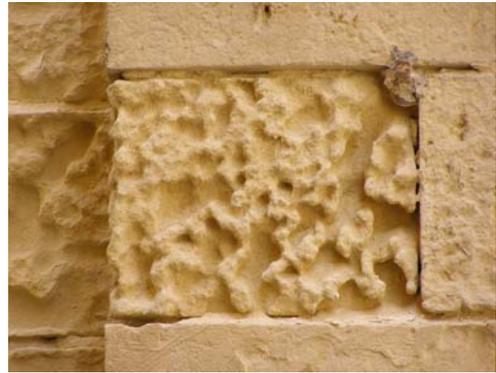
**Fig. 1.** Honeycomb weathering of *Globigerina* limestone, Malta, controlled by patterns of fossil bioturbation (approximate image width 70 cm).

It is the general susceptibility of oolitic and other granular limestones to physical weathering, especially salt weathering, that sets them apart from dense limestones and from the general preconceptions regarding the pre-eminence of solution loss. Because of this it is more common to see these limestones affected by patterns of decay that one normally associates with sandstones rather than with the surface dissolution of limestone. Although such decay may begin with limited surface loss through granular disaggregation, decay eventually begins to concentrate spatially leading to localized accelerated retreat forming characteristic alveolar weathering or ‘honeycombing’ of the stone (Fig. 1). Once retreat has been initiated small hollows can amalgamate to form larger cavernous hollows or Tafoni (Fig. 2). Once

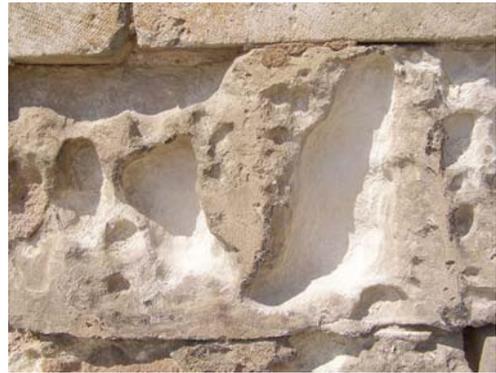
**Fig. 2.** Cavernous hollows developing on a Quaternary calcarenite, Mallorca (approximate image width 40 cm).

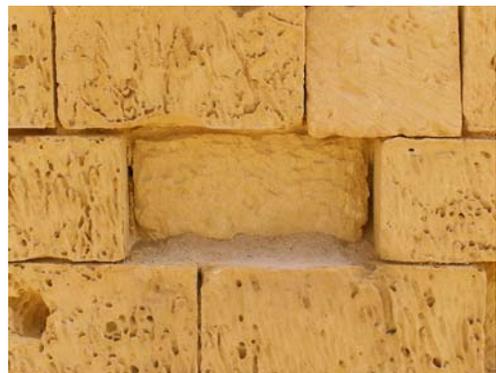
**Fig. 3.** Catastrophic decay of an individual block of *Globigerina* limestone, Malta (approximate image width 2 m).

small-scale cavernous hollows are initiated in oolitic limestones, like those used in cities such as Oxford, there is ample visual evidence that individual blocks (Fig. 3) and, ultimately, whole sections of wall (Fig. 4) can become prone to rapid and, eventually, catastrophic decay. Invariably this is associated with the near-surface presence of salts (e.g. Espinoza-Marzal & Scherer 2010), such as gypsum within the cavernous hollows, and is achieved by a combination of multiple flaking and, especially, granular disaggregation.

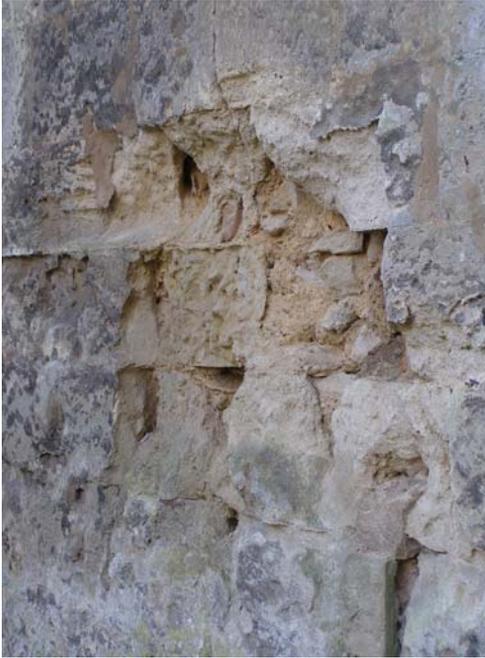
**Fig. 4.** Catastrophic decay of a section of wall constructed of Jurassic oolitic limestone, Oxford (approximate image width 4 m).

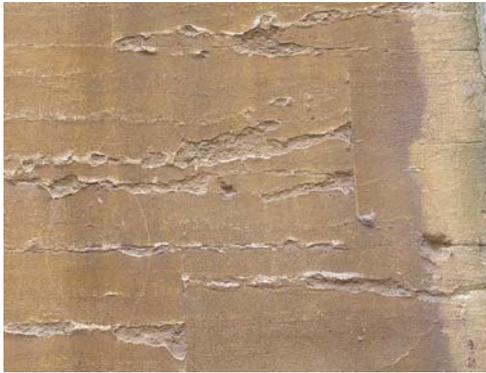
**Fig. 5.** Decay of a Jurassic oolitic limestone initiated along clay partings within the stone, Oxford (approximate image width 1 m).

The first step towards understanding long-term performance is knowledge of what controls the initiation of surface irregularities within which, for example, salts can accumulate. These may originate through slight variations in surface topography produced during the initial working of the stone, but a more general source of spatially concentrated decay may lie in structural and textural variations. In laboratory simulations of salt weathering carried out on oolitic limestones Smith *et al.* (2008*b*) identified meso-scale structural diversity, such as that associated with distinctive bedding (Fig. 5), fossil bioturbation (Fig. 1) and texturally different inclusions such as clay lenses, as potential focal points for localized decay. In highly polluted environments, however, sulphation (the chemical reaction of  $\text{CaCO}_3$  with water acidified by  $\text{SO}_2$ ) can be so rapid that it can quickly mask any surface heterogeneity through the development of a surface gypsum crust, especially in areas sheltered from large amounts of surface runoff. In these areas gypsum crusts can act as a hard, relatively impermeable surface, but once breached they may fail

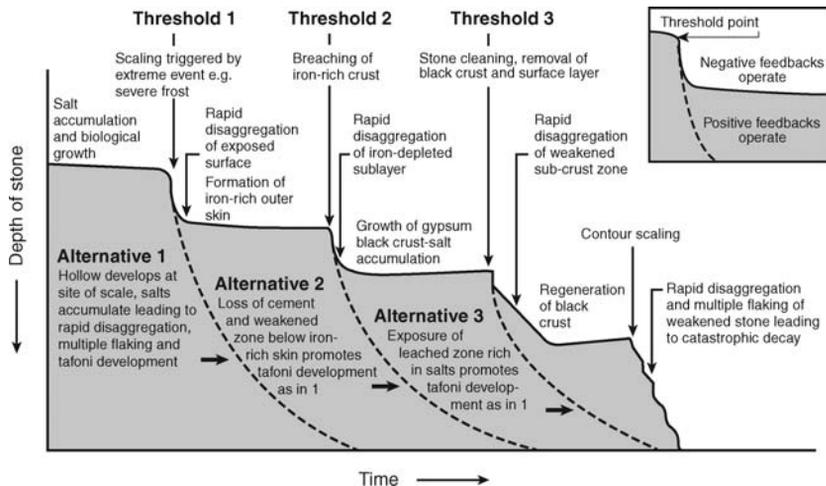
**Fig. 6.** Hypothetical decay pathways for quartz sandstone used as a building material in a polluted environment. The inset identifies feedback options at critical thresholds of decay associated with rapid surface loss of material. Adapted from Smith *et al.* (1994) and Smith (2003).

walls, its patchiness over wall surfaces, and its complex relation to salt, climatic conditions and pollutant content (Viles 1993; Antill & Viles 1999). Archival investigations of blister development, climate and air pollution over the period 1864–1937 in central Oxford have also indicated particular ‘spasms’ of blistering (which cannot easily be related to any specific environmental variable) followed by relative stability. Such episodic and complex production of catastrophic decay features poses a severe problem for the conservation and management of historic buildings and monuments, as well as presenting difficult challenges when choosing potential stabilization procedures or replacement stone types. Studies of the rapid decay of non-calcareous stones may again provide some insight into the nature of this decay and what controls its operation. This is because, in the absence of slow and gradual decay in response to surface dissolution, a more appropriate paradigm for the decay of stones such as quartz sandstones is one based on periods of relative surface stability followed by short-lived episodes of rapid surface loss (Smith *et al.* 1994, 2003). The first episode of rapid loss may very well be associated with the sudden loss of a surface gypsum crust and the rapid erosion of a weakened subsurface layer. After this is removed, the stone appears to be faced by one of two choices, either negative feedbacks come into play or, as described above, the initiation of a localized hollow can trigger a number of positive feedbacks that accelerate decay leading to catastrophic loss (Fig. 6).

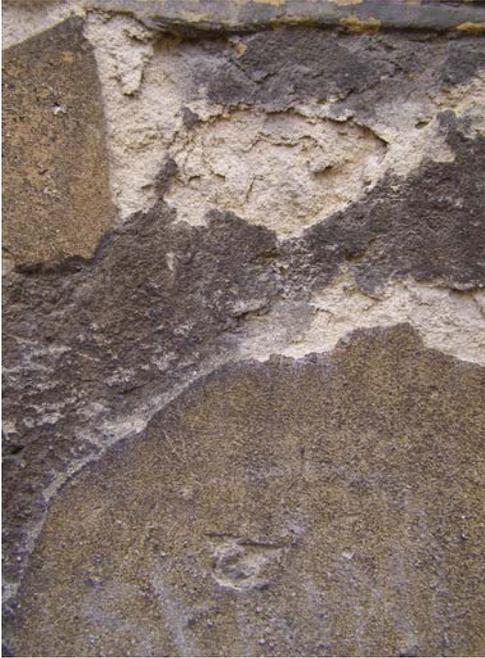
**Fig. 7.** Multiple gypsum crusts on Jurassic oolitic limestone, Oxford (approximate image width 50 cm).

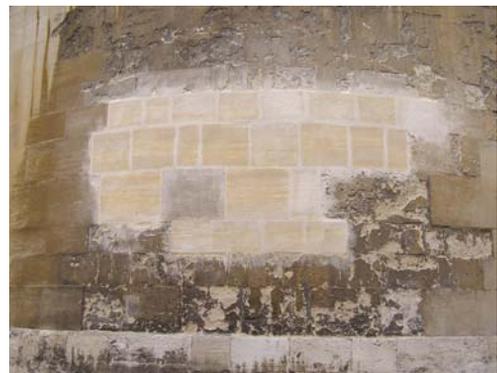
**Fig. 8.** Replacement of a section of wall in Oxford previously destroyed by catastrophic decay of Jurassic oolitic limestone (approximate image width 6 m).
